Damage assessment from the Mw 7.8 Ecuador earthquake of April 2016 field mission

Eduardo Miranda Andrés Acosta Luis Ceferino Stanford University

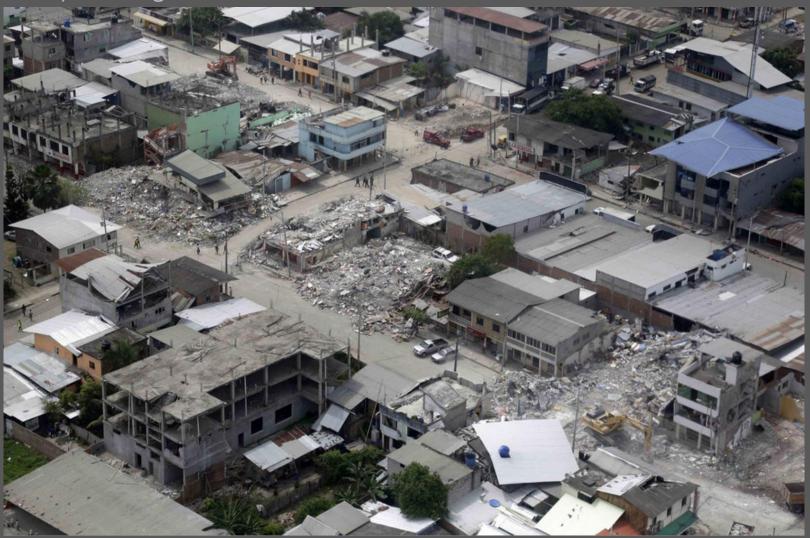
Heavy damage

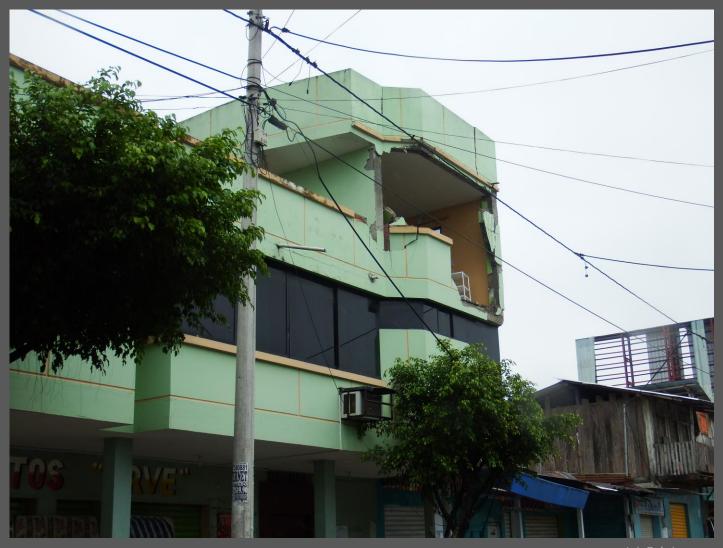
Out-of-plane failure

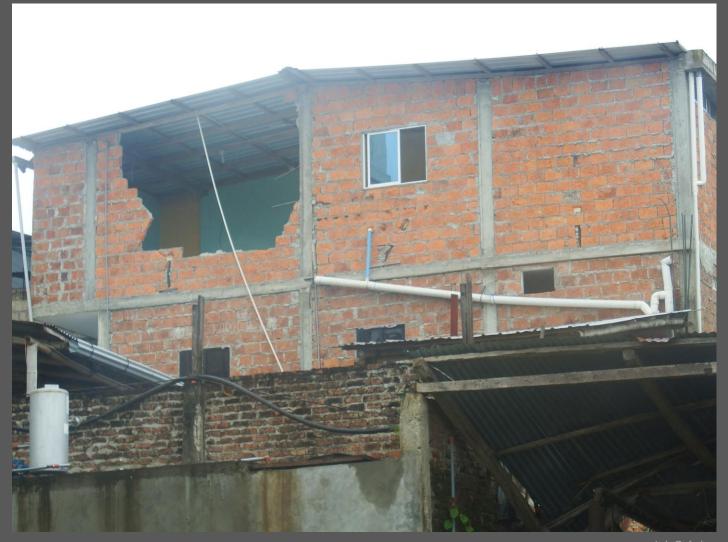
Out-of-plane failure

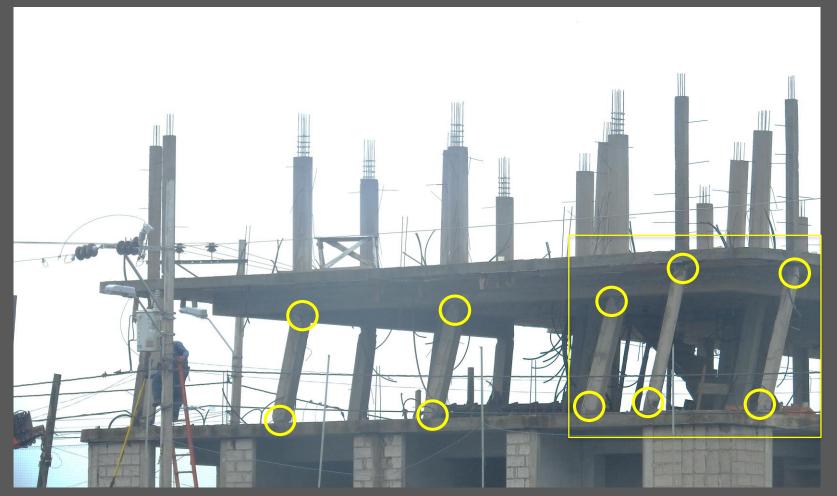
Collapse mechanism

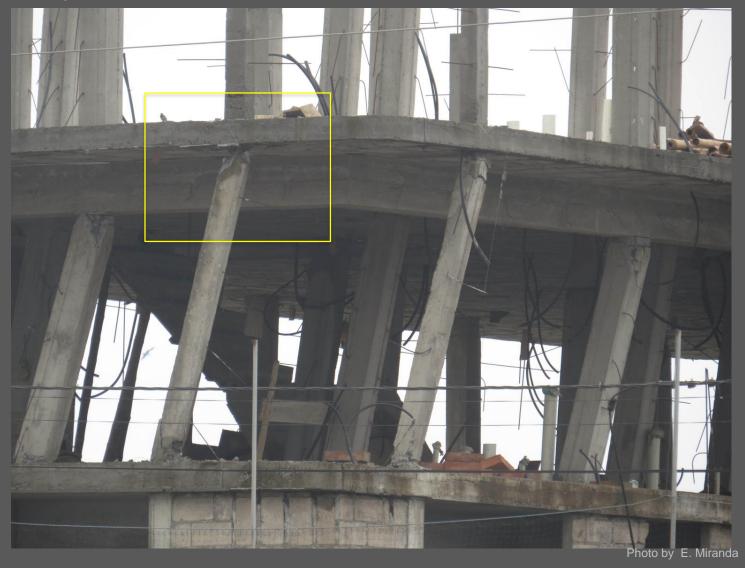
Collapse mechanism

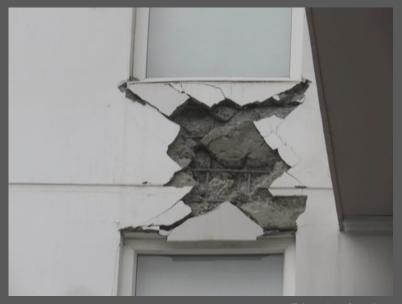
Coupling Girder Failure
