Damage assessment from the Mw 7.8 Ecuador earthquake of April 2016 field mission

Eduardo Miranda Andrés Acosta Luis Ceferino Stanford University

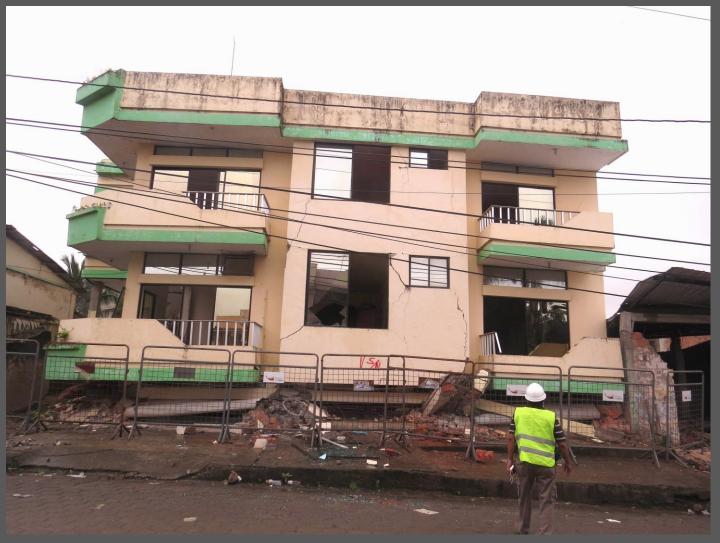
Soft story collapse

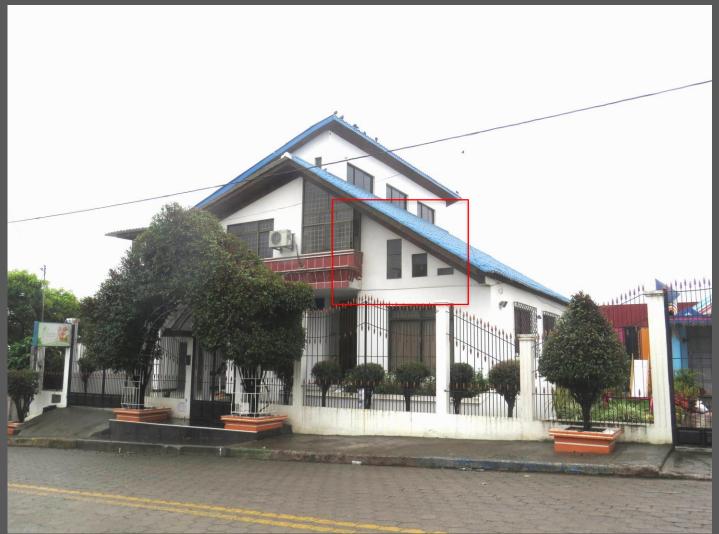
Practically no sign of an earthquake

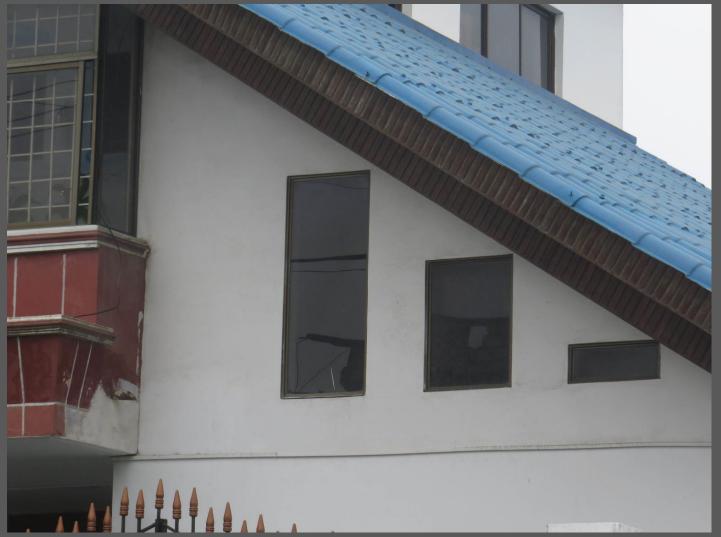
Practically no sign of an earthquake

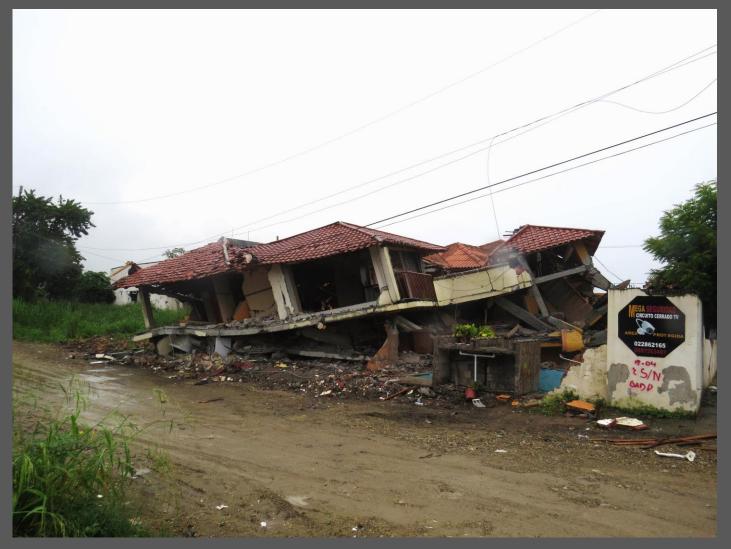
Collapse of small hotel

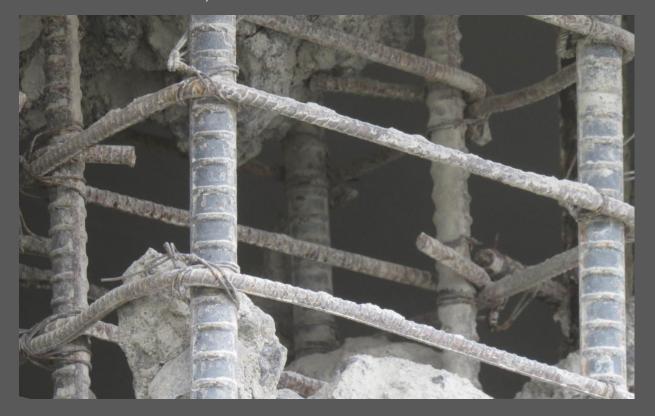
School "Atahualpa". Column rebars

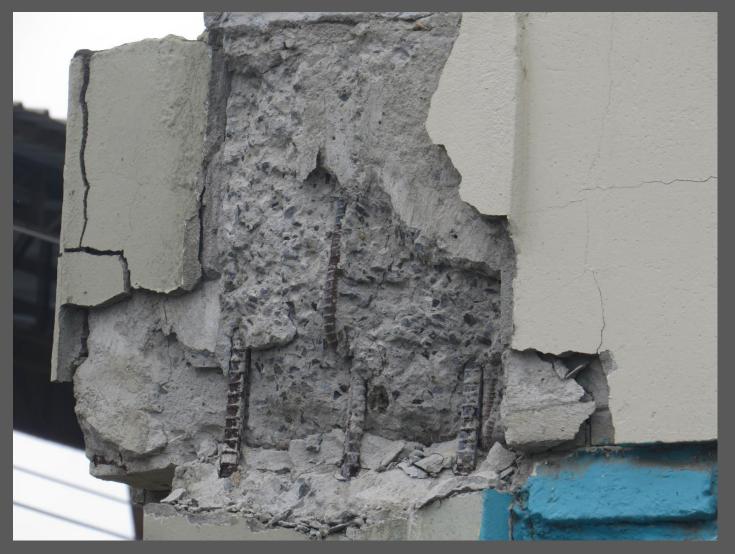
School "Atahualpa"

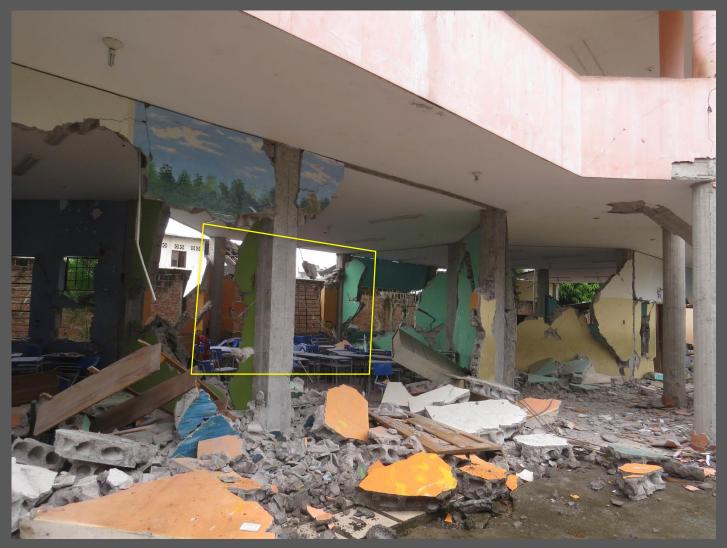
School "Atahualpa". Interior view

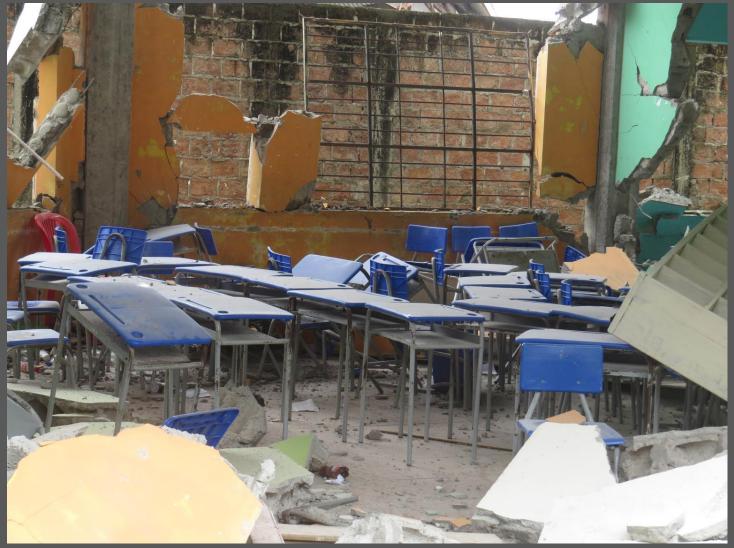
School "Atahualpa". Interior view

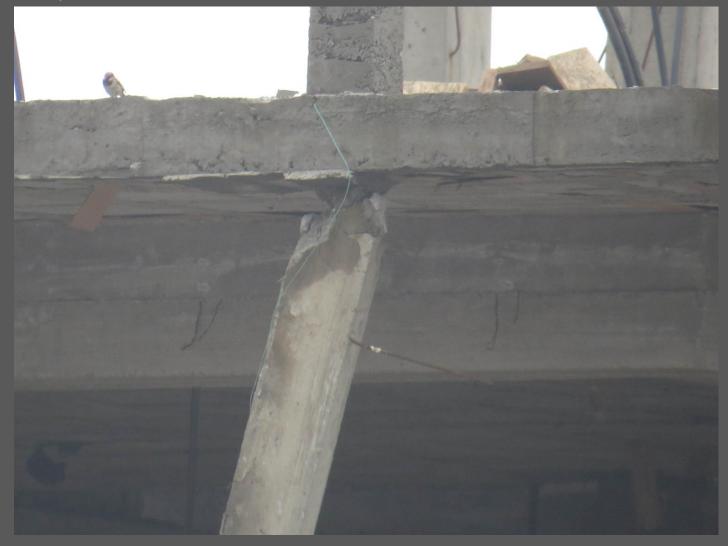
Collapse mechanism

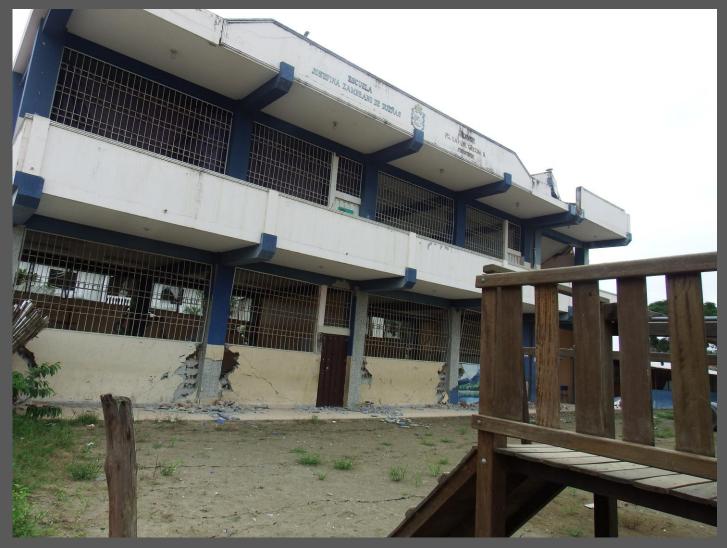
School "Josefina Zambrano"

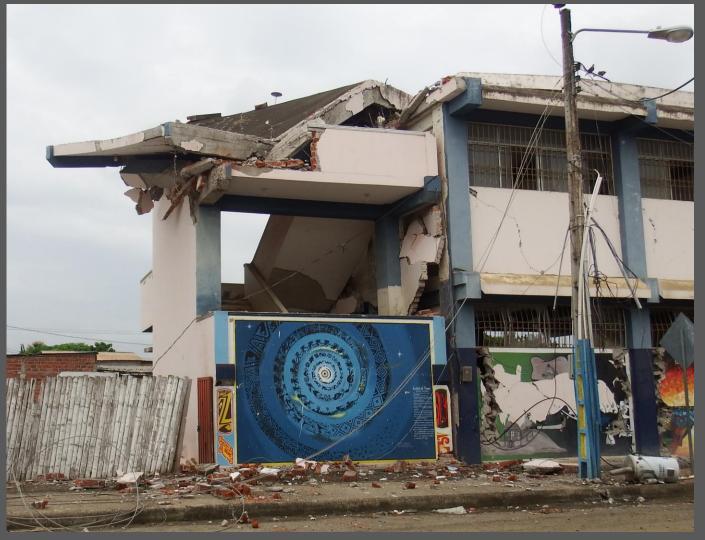
School "Josefina Zambrano". Partial collapse

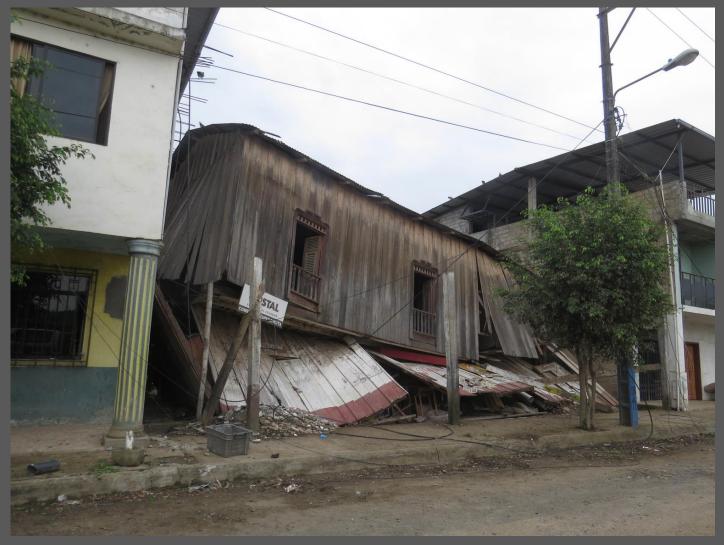
Collapse of wooden house

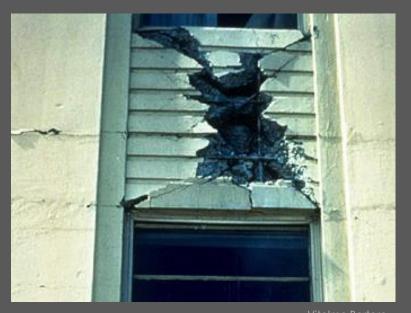
Coupling Girder Failure

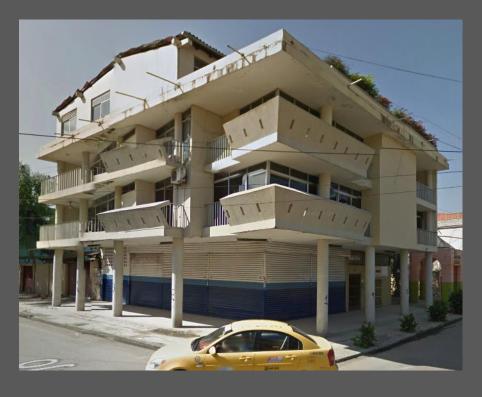
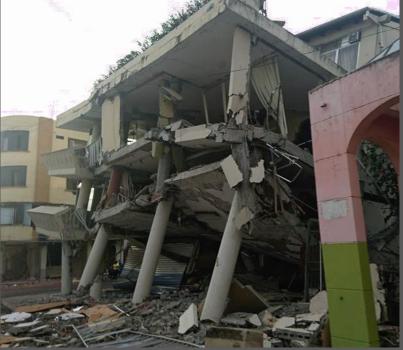
Downtown Portoviejo

Before After
